The Utah State Safety Inspection standard for passenger vehicle and light truck windshields will change on September 27, 2016. The old standard rejected any windshield for damage in the acute area greater than one inch (1") in length or diameter. The new standard, along with examples is provided below. Any law enforcement action (traffic stop, citation, warning, fixit ticket, etc.) under U.C.A. 41-6a-1601 taken as a result of a damaged windshield should be based on the new standard as of September 27, 2016.

ACUTE AREA

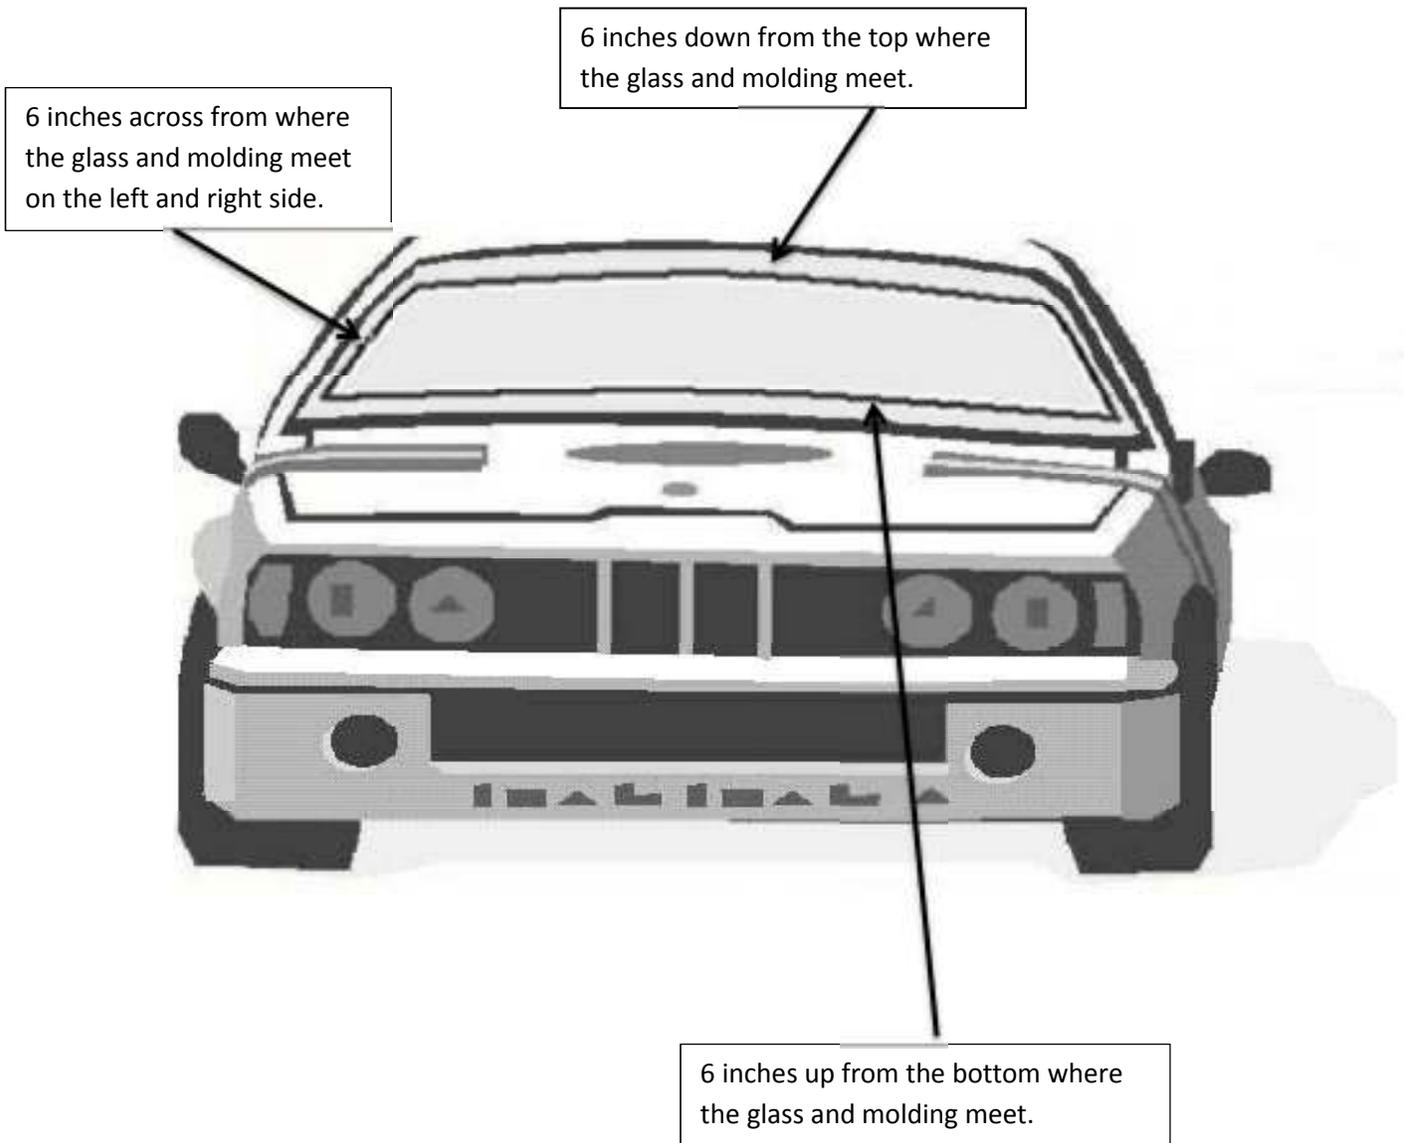
The acute area (measured on the outside) of the windshield is defined vertically by measuring six inches (6") down from the top edge of the glass where it meets the molding, six inches (6") up from the bottom edge of the glass where it meets the molding. Horizontally, by measuring six inches (6") in from the left edge of the glass where it meets the molding and six inches (6") in from the right side edge of the glass where it meets the molding.

***Multiple cracks/damage may be in the 6" border outside of the acute area.

***All measurements are taken on the outside of the glass from the edge where the glass and molding meet.

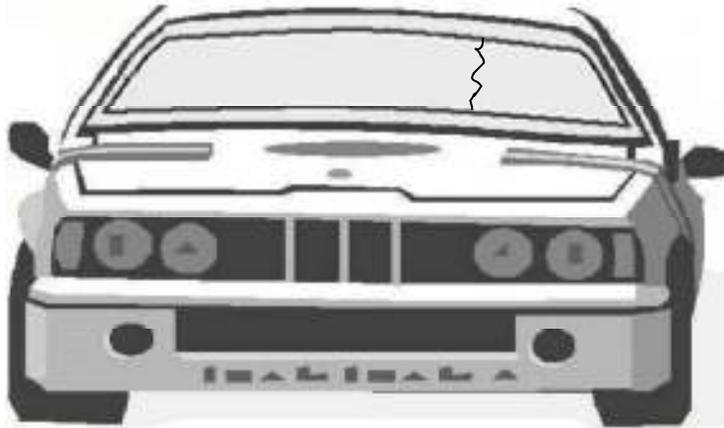
PASS

ANY CRACK INTERSECTS WITH ANOTHER CRACK WITHIN THE ACUTE AREA

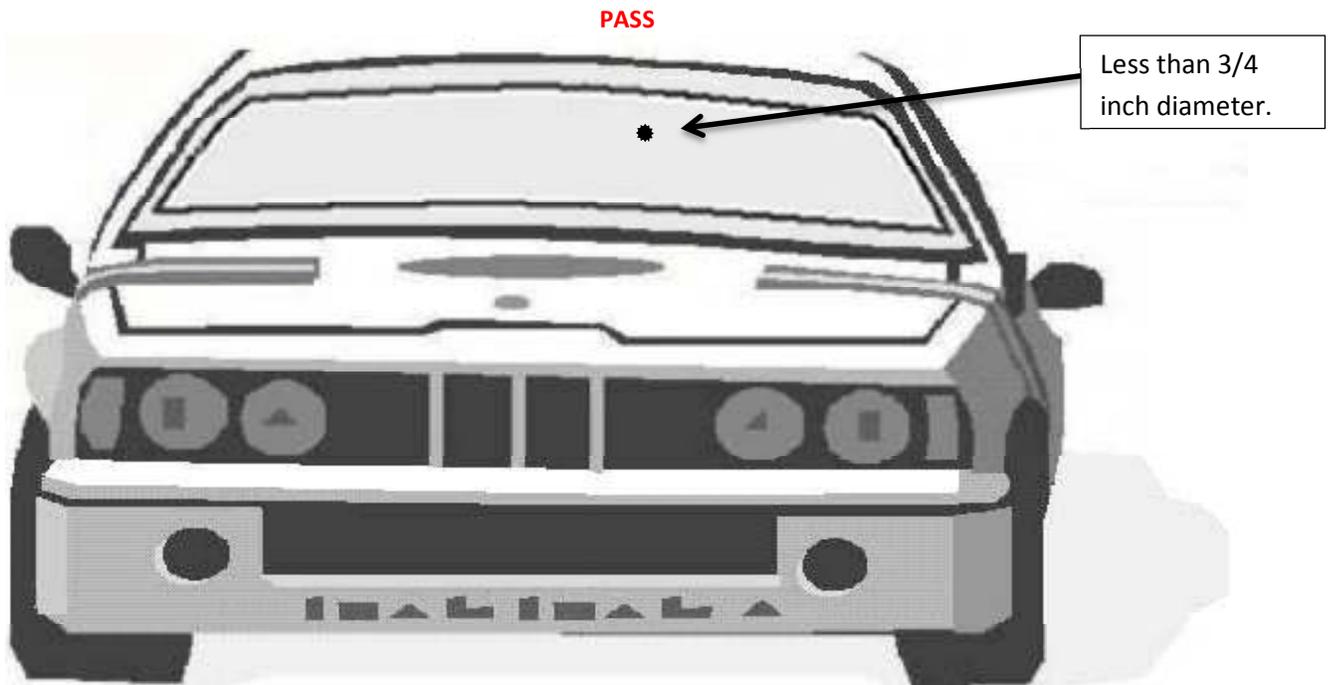
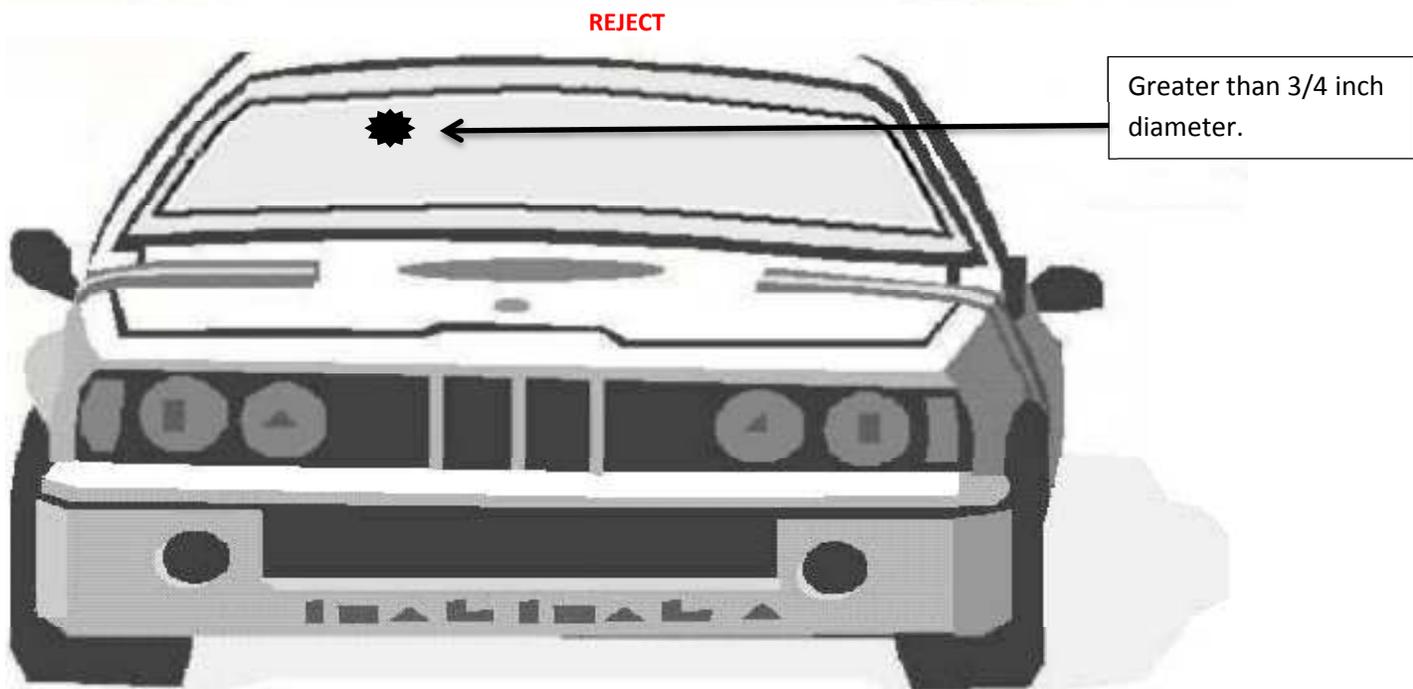
THERE IS ANY DAMAGE WITHIN THE ACUTE AREA THAT CANNOT BE COVERED BY DISC 3/4 INCH IN DIAMETER
(A 3/4 inch disc is about the size of a penny)

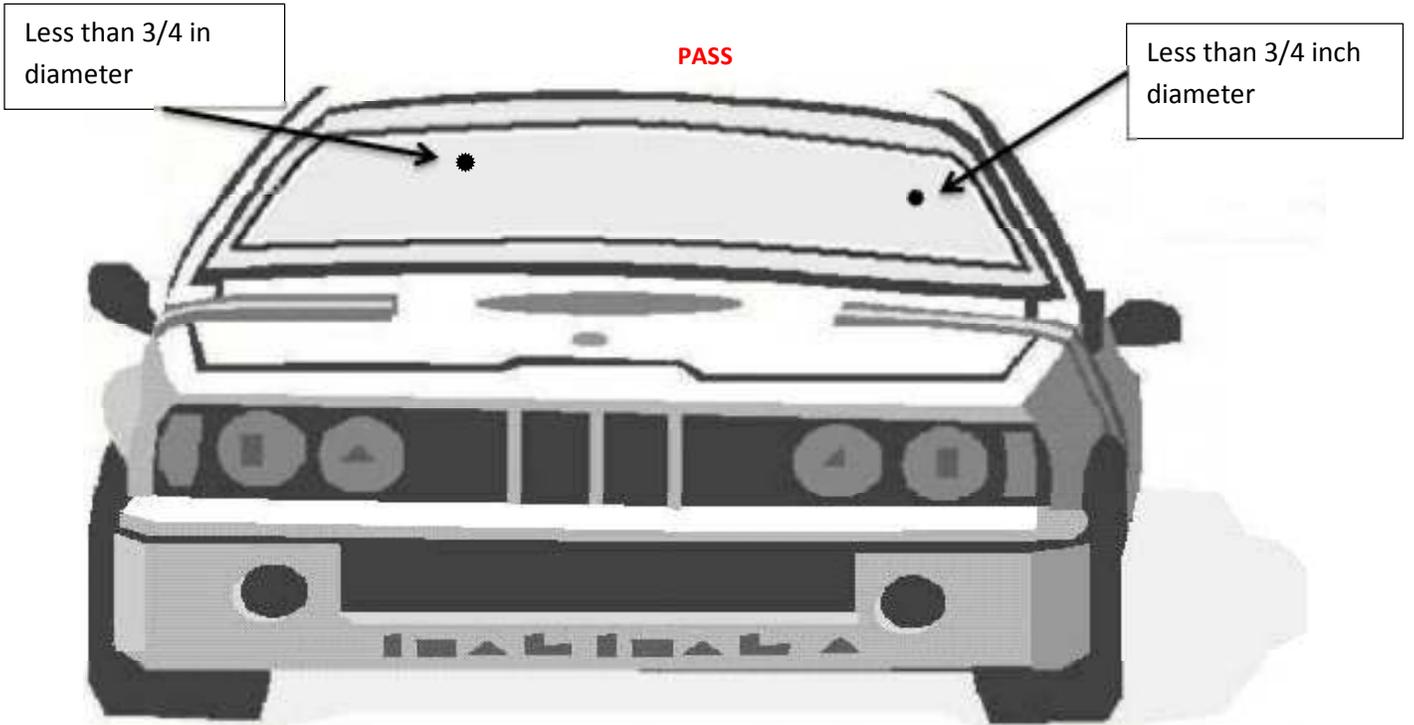
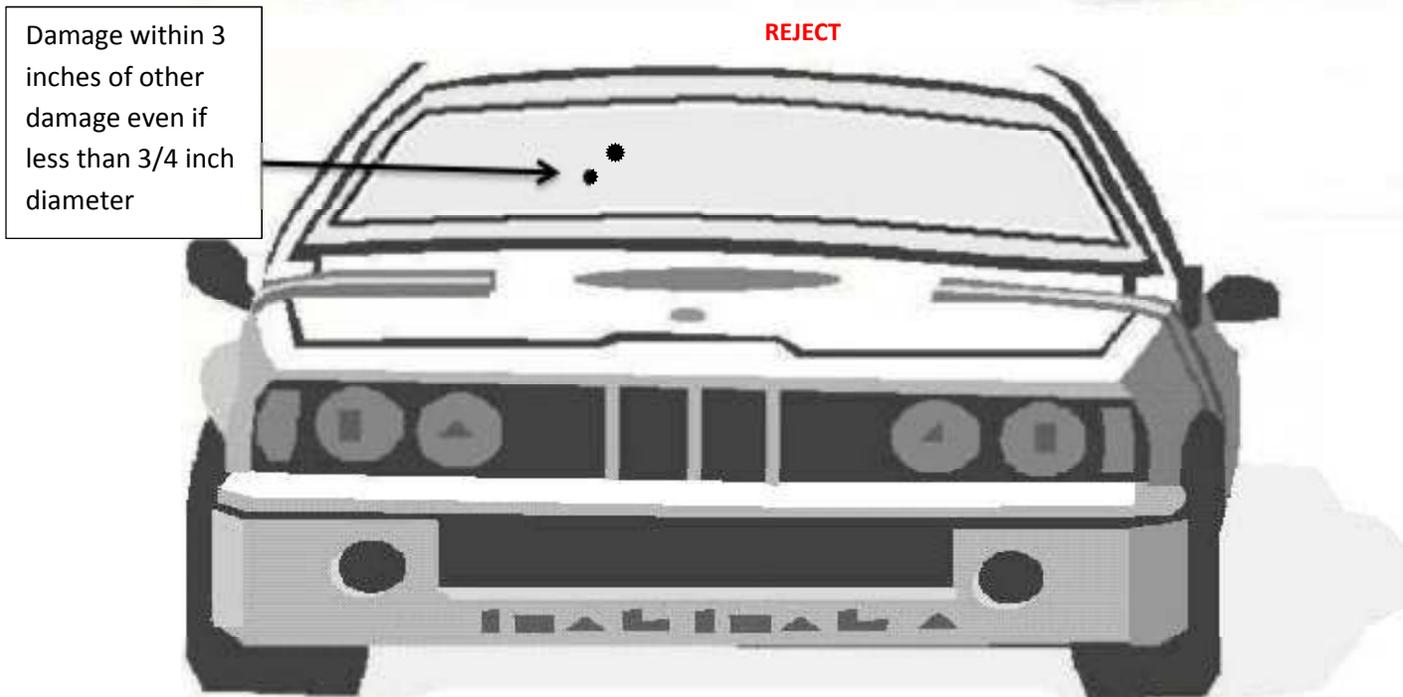
THERE IS ANY DAMAGE IN THE ACUTE AREA THAT IS WITHIN 3 INCHES OF ANY OTHER DAMAGE IN THE ACUTE AREA.
